# City of Ottawa

## Main Street Road Safety Audit

FINAL REPORT

CIMA+ File Number: B000957

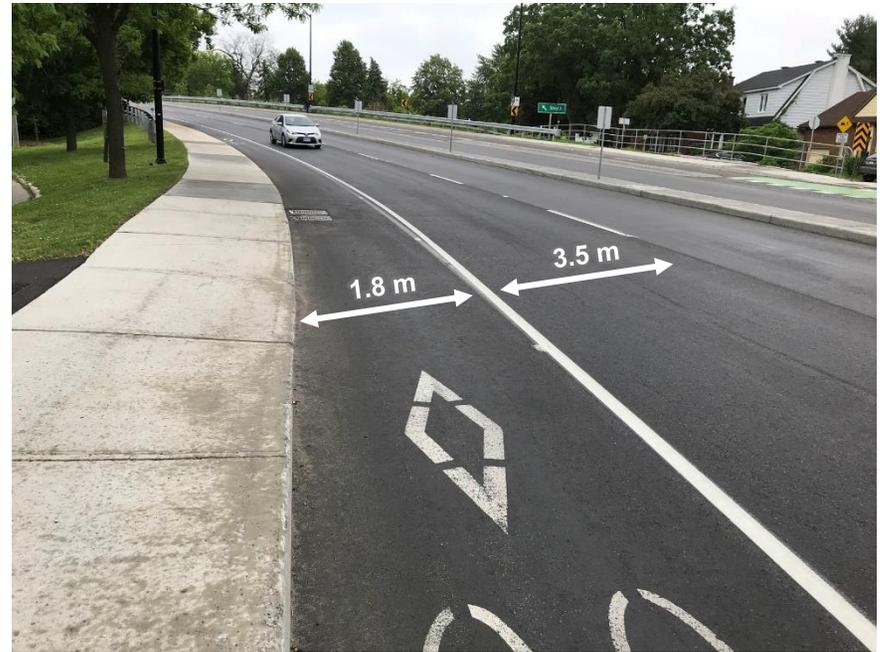
Trucks were observed encroaching the northbound bicycle lane on the curve located north of the Rideau River bridge. The width of the bicycle lane at this point is 1.80 metres, which is the desirable width according to Ontario Traffic Manual. The width of the general purpose lane is 3.50 metres. Although these lanes are within the range recommended by Transportation Association of Canada for urban roads, similar to Main Street, large vehicles appear to have difficulty remaining within their lane along this curve (potentially due to their speed).

With enforcement and/or traffic calming treatments, the occurrence of trucks encroaching the bicycle lane can be reduced. It should be noted that since our field investigation, the City has installed vertical flex-stakes between the dedicate bike and general purpose lanes, as a measure to better delineate the two separate facilities. As such, the City should monitor truck behaviours to verify if this modification was effective.

Flexible delineators (“flex stakes”) are installed annually at this location (removed during the winter months due to road maintenance requirements). The flex stakes are expected to keep vehicles (including trucks) from encroaching in the cycling lane. **The City will review operations during the winter months when the flex stakes are not in place.**

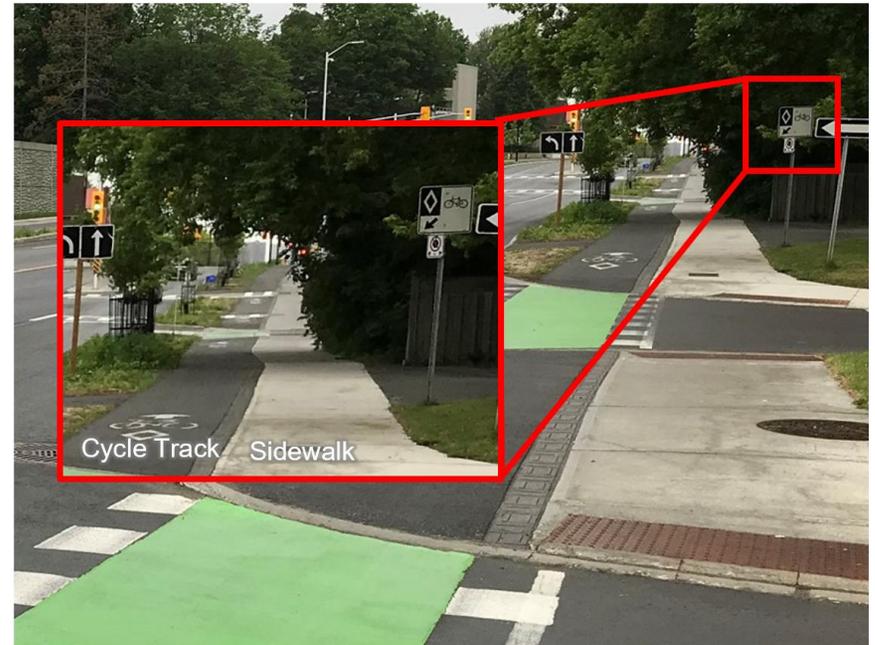
At some locations, the ground mounted Reserved Bicycle Lane signs are installed adjacent to the sidewalk. This makes the diagonal arrow on the sign point at the sidewalk, as opposed to the cycle track. This was observed at three locations along Main Street: northbound near Toronto Street and near Hawthorne Avenue, and southbound near Harvey Street.

Where this condition occurs, the Reserved Bicycle Lane signs should be mounted to the left of the cycle track, such that the diagonal arrow points at the cycle track. Although this may not be a typical standard, it provides a more clear indication of where cyclists should ride.

Moving the signs to the left of the cycle track would increase the driver workload, particularly in locations where there are already other signs posted nearby (such as in the photo above). Additionally, primary signs are typically placed on the right side of a facility, making this sign placement consistent with what cyclists may expect. No changes are planned since it is not expected that the sign placement would be the cause of conflicts or collisions.

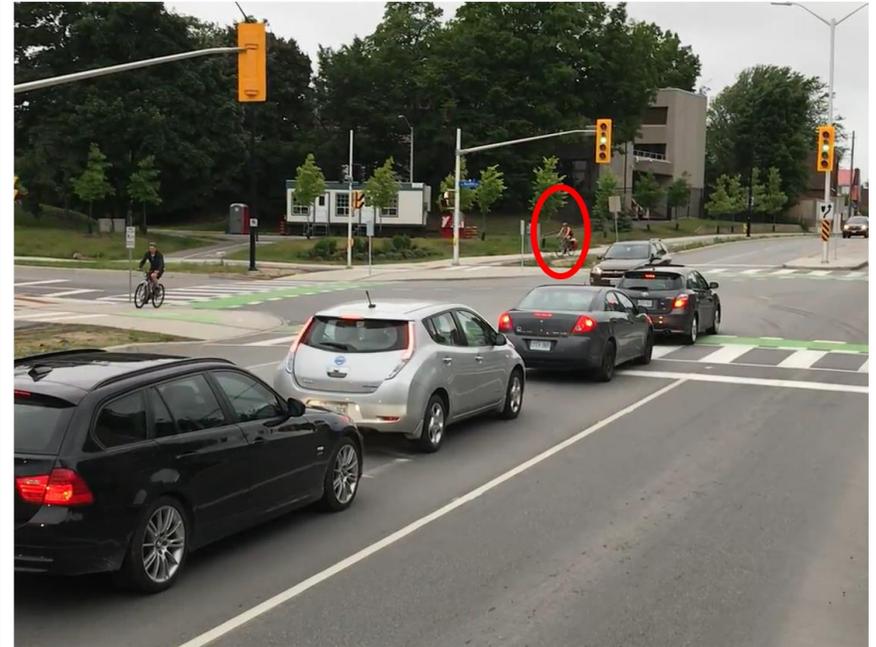
It should also be noted that due to the downslope of Main Street at this location, in the southbound direction, cyclists gain speed and will have difficulty completing an emergency stop, if needed.

Installing a “Turning Vehicles Yield to Bicycles” sign on the signal mast arm can increase left-turning drivers’ awareness of the presence of southbound cyclists. Additionally, subject to traffic operational analysis, consideration may be given to implementing protected-only left-turn signal phasing for the northbound direction. This would completely separate this movement from southbound cyclists and reduce the potential for conflicts; however, this will further impact vehicle capacity constraints at this location.

See response to Finding # 4 above. At this time, an additional sign facing northbound traffic is not recommended since the sign would add to driver workload and may or may not actually provide a benefit.

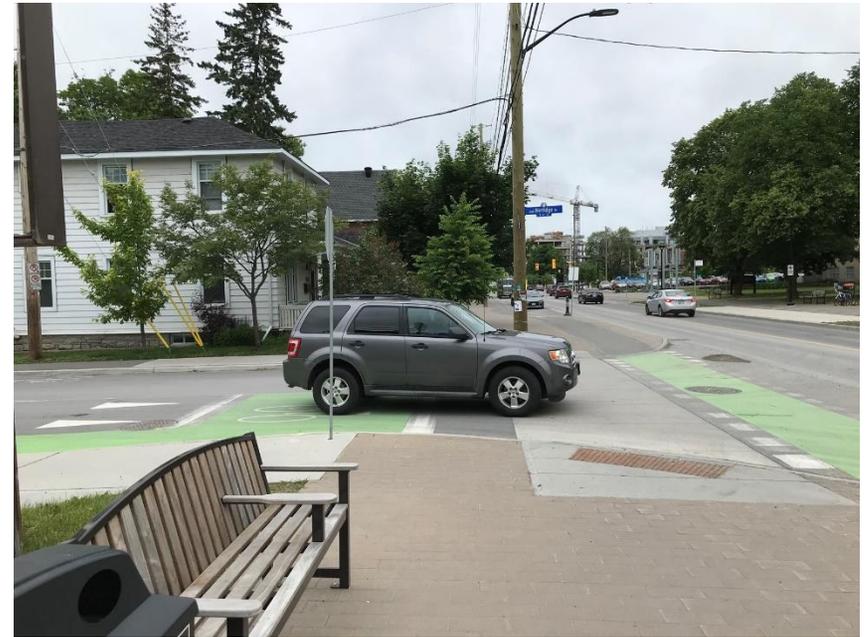
A bike box is provided at Herridge Street & Main Street. During the field investigation, vehicles were observed encroaching the bike box while advancing to clear sight lines (i.e. pulling up to look for oncoming traffic).

Given Herridge Street is stop controlled and a single lane approach to a T-intersection, consideration may be given to removing the bike box on the approach to Main Street.

Based on feedback received, it appears as though the purpose of this bike box is not well understood. During a public meeting with the Old Ottawa East Community Association, there was quite a bit of discussion regarding the intent of the bike box. Additionally, the written feedback received from the Community Association also indicates that cyclists could cross Main Street at Hazel or Clegg (both of which are signalized), rather than crossing at Herridge. Whereas this is true, these routes would lead cyclists to either go out of their way in order to reach their destination, or to cycle the wrong direction on the east side of Main Street.

Given that it is not expected that the bike box is likely to cause any collisions or near misses, the bike box will remain. If, however, the City observes concerns regarding cyclist safety at this crossing (ie: complaints regarding near misses, or collision data), the City will consider removing the depressed curb on the east side of Main Street (across from Herridge) and the bike box on Herridge. **The City will review 3-year collision data once available.**

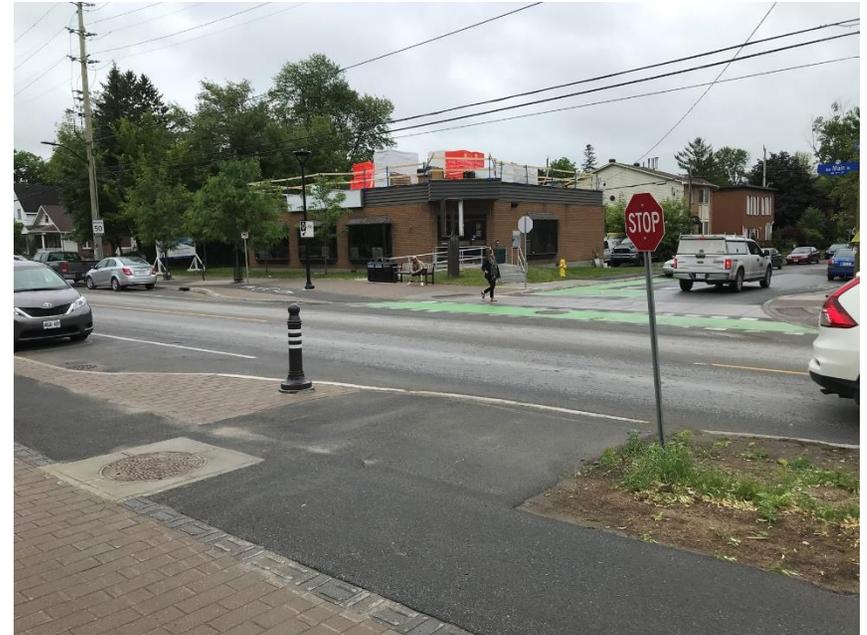
A Stop sign and waiting area is provided opposite to Herridge Street (i.e. east side of Main Street) to indicate to cyclists where to cross Main Street. A similar treatment is not provided on the west side of Main Street. This location is in front of Saint Paul University, which is a major pedestrian and cyclist generator within the study area. During field investigations, several cyclists were observed arriving at the University from the north, riding on the sidewalk on the east side of Main Street (i.e. riding the wrong way on the cycle track or sidewalk). This could be due to the lack of an indication for where to cross Main Street from the west to the east side.

Consider providing a proper bicycle crossing treatment on Main Street, in the vicinity of Saint Paul University, or, at a minimum, provide a more apparent indication for where cyclists should cross from the west to the east side.

See client response for Finding #9. The bike box is intended to facilitate the eastbound crossing.

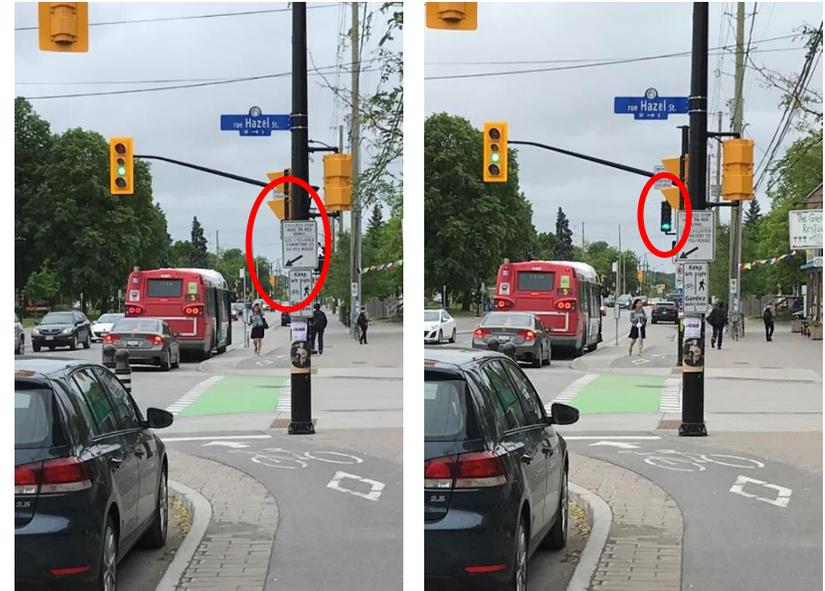
At several locations, bicycle signal heads were found to be obstructed by signage as cyclists approach intersections. This may not provide cyclists sufficient distance/time to observe red light indications. This was observed at several intersections within the study area, particularly where the cycle track shifts laterally on the approach to an intersection.

Relocate bicycle signal heads and/or signage where practical, ensuring signals are not obstructed as cyclists approach them.

The City will review signage along the corridor and will determine if any changes should be made to improve visibility of signal heads.

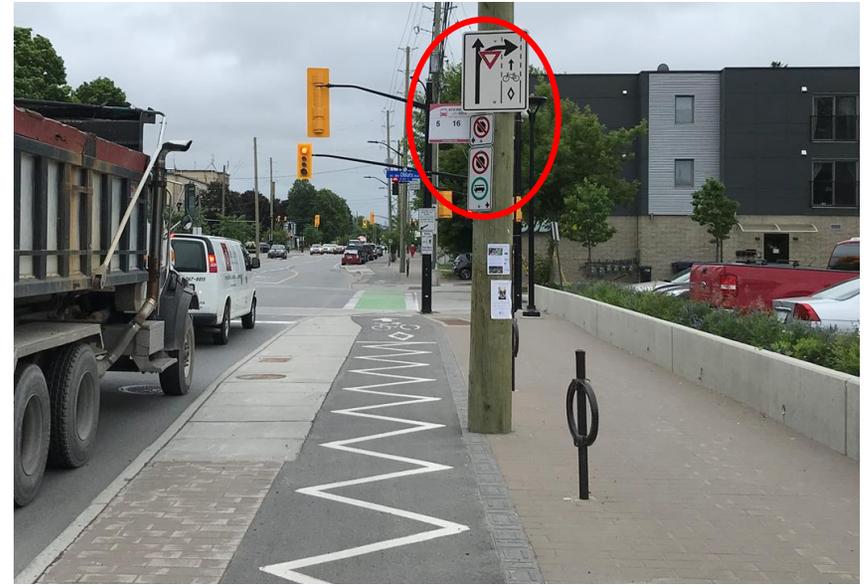
The picture and location figure shows a bus stop near Main Street & Oblate Avenue; however, this finding was observed at multiple locations within the study area.

Where possible, rearrange signage to reduce clutter. For example, in the picture shown, the "Turning Vehicles Yield to Cyclists" sign could be relocated to the left side of the cycle track on its own support, and the bus stop sign could be relocated above the parking regulations on the hydro pole.

The City will review signage along the corridor to identify if there is any signage that should be changed due to sign clutter and driver workload. It should be noted however that in situations such as the one shown above, it is generally accepted that the signs can be located in near proximity to each other if required and/or if the general message of the signs are compatible.

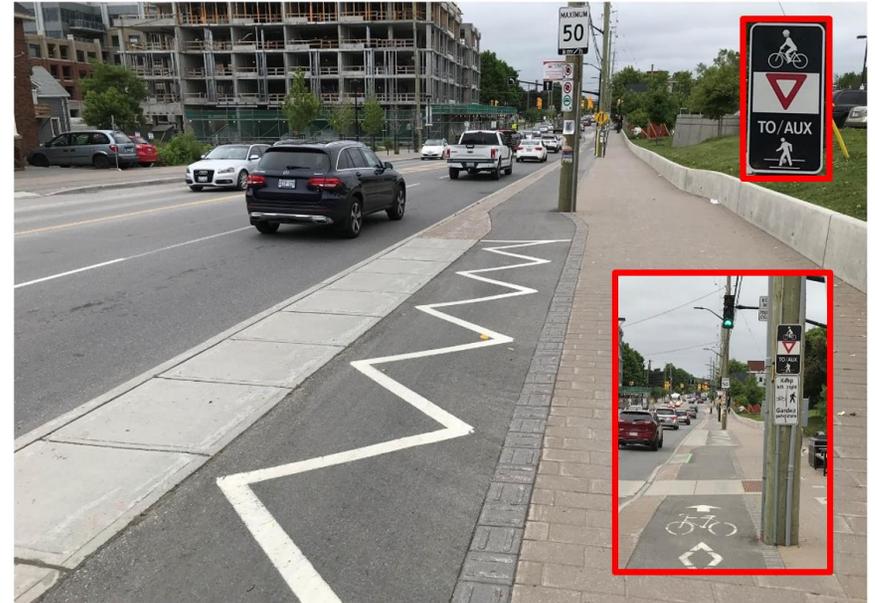
Additionally, one bus was observed offloading passengers outside the areas designated bus stops (i.e. areas with zigzag patterns). This was observed during the PM peak hour, when congestion created long queues. A passenger was seen getting off the bus and across the cycle track without looking for approaching cyclists.

As opposed to zigzag pavement markings, consider pictographic pavement markings (e.g. yield sign pavement markings, “watch for pedestrians” message markings, etc.)

The signs and markings implemented at this location are based on the design that the City of Ottawa was using while the Main Street facilities were being designed. Since this time, there have been changes made to the standard design that the City uses. OC Transpo is currently finalizing the recommended standard design. The input received at this location will be provided to OC Transpo for their information in creating the new design standard.

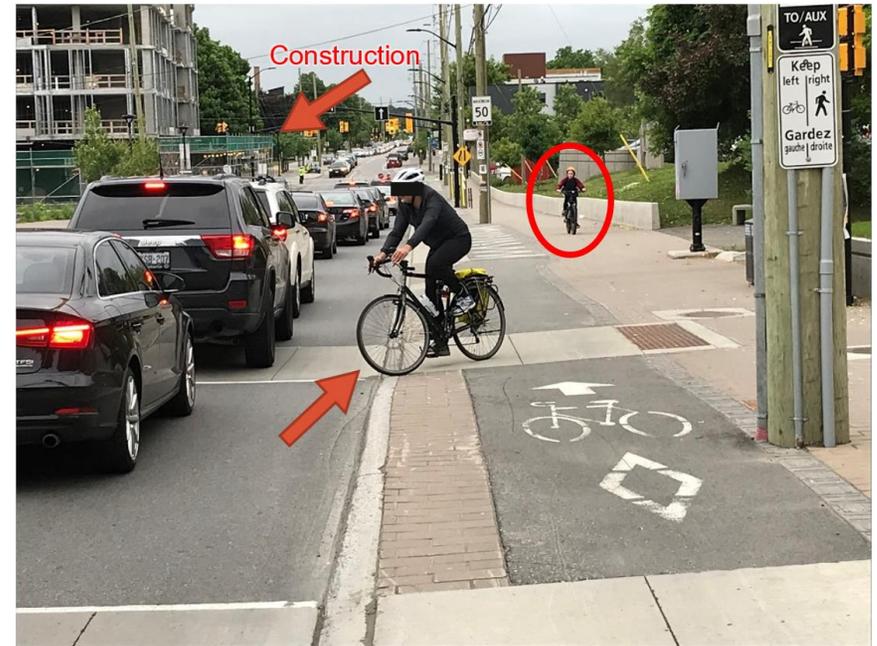
Several cyclists were observed riding on the sidewalk and travelling the wrong way on the provided cycle tracks, as well as crossing Main Street using crosswalks without dismounting. One cyclist was asked if there was a specific reason why they preferred using the sidewalk in the opposite direction of the cycle track, and she indicated that it felt safer than riding under the construction scaffolding on the east side of Main Street, near Oblate Avenue.

Other inappropriate cyclist behaviours included disobeying the red light at bicycle signals. This was observed at several locations within the study area, with one of the most critical locations being the southbound approach to Riverdale Avenue, where the downgrade can encourage high bicycle speeds.

Under the Ontario Highway Traffic Act, cyclists must obey their traffic signals, and are not allowed to ride on crosswalks. Additionally, cycling on the sidewalk is prohibited by the City of Ottawa Traffic and Parking By-law, except where it is permitted by official or authorized signs. Consideration should be given to conducting targeted cyclist enforcement and education to reduce these occurrences over time.

Cycling behaviours were also identified as a priority item in the written feedback received from the Old Ottawa East Community Association, as were pedestrian behaviours and motorist behaviours. **The City will employ ambassadors in Spring/Summer 2019 (near the start of the next cycling season) in order to help emphasize the purpose of various cycling facilities.** If required, enforcement may be requested in the future.

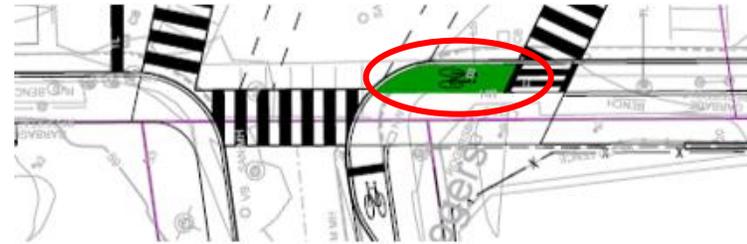
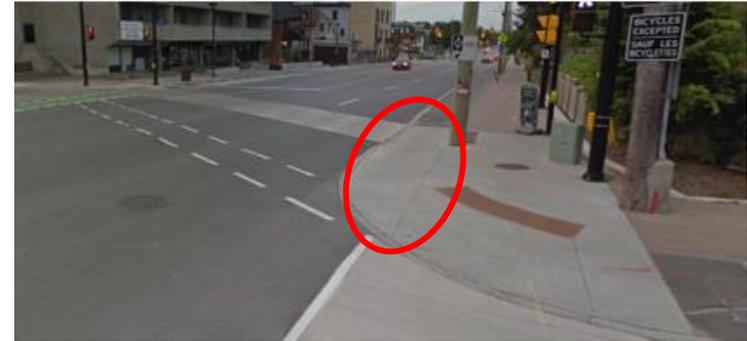
The southbound Main Street cycle track begins at Graham Avenue. The design drawings indicate green coloured pavement at the southwest corner to show where cyclist should enter the cycle track. However, the actual field condition does not include the coloured pavement. The start of the cycle track appears to be a regular sidewalk. During the site visit, cyclists were observed riding on the crosswalk and part of the sidewalk before getting to the cycle track.

Provide coloured pavement (per the design drawing) to clearly indicate the start of the southbound cycle track at Main Street & Graham Avenue.

Alternatively, provide a southbound cross-ride with an overhead bike signal indicator, similar to the northbound direction.

Based on our current design practices, this section of cycle track would typically be asphalt rather than concrete. Given that it is not cost effective to remove the concrete and replace it with asphalt, **the City will add green thermoplastic paint to this location to help delineate the cycling facility.**

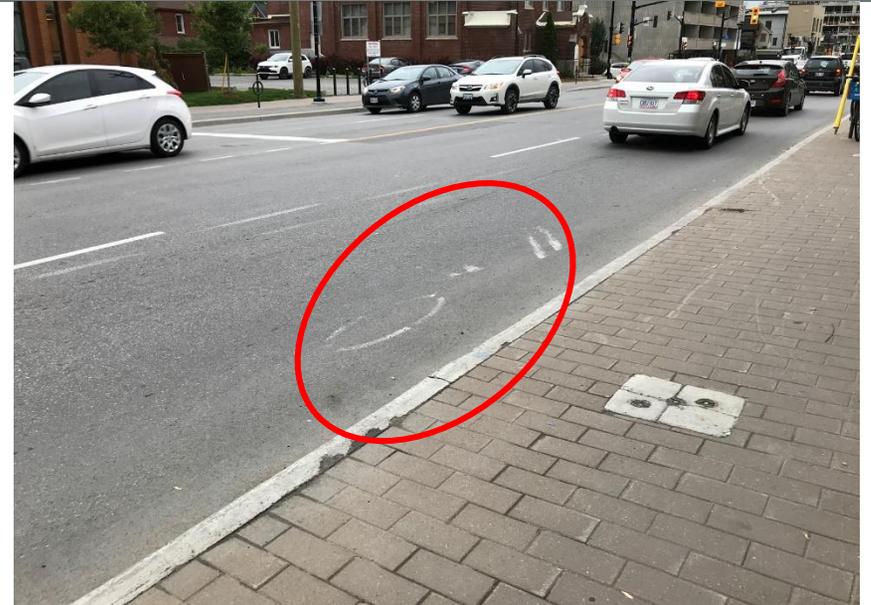
At the northernmost section of the study area, cyclists share the road with motor vehicles. “Sharrow” pavement markings are provided to indicate the shared condition; however, several of these markings are significantly faded.

Ensure pavement markings are maintained throughout the year to indicate to drivers and cyclists the shared condition of the roadway.

These markings are already be included in the City’s annual pavement marking maintenance schedule.

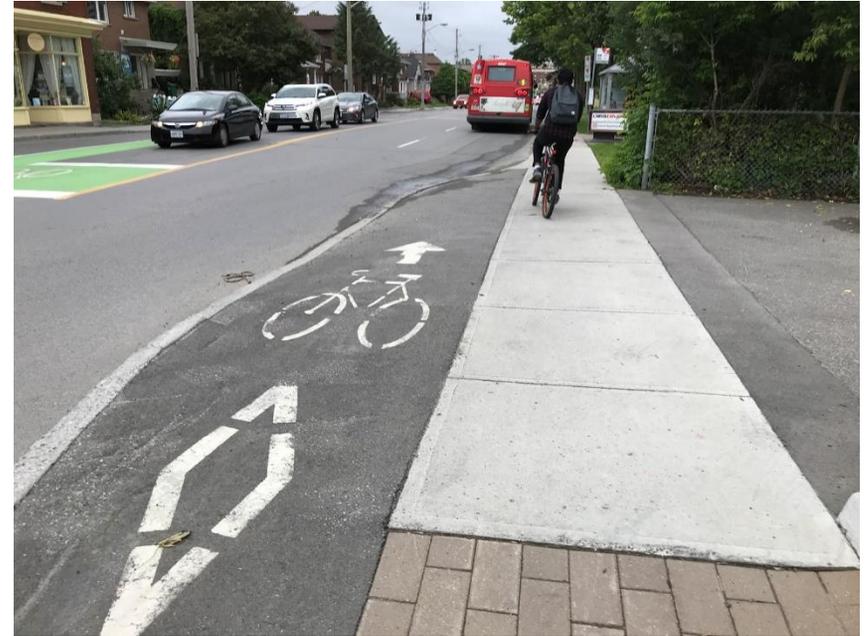
A very short section of cycle track (approximately 10 metres) is provided on the north side of Hawthorne Avenue, immediately west of Main Street. A bus stop is located west of the termination of this cycle track section. Buses were observed encroaching this cycle track with the front overhang when completing a northbound left-turn from Main Street.

Additionally, multiple cyclists were observed not using this cycle track (either riding on the sidewalk or on the roadway). Potential reasons for this are; there is no cycle track on Main Street southbound, and using the cycle track may be uncomfortable for cyclists, as the cycle track is raised and depressed over a short distance.

Consider extending this section of cycle track. However, this would require moving the existing bus stop further away from the intersection. Alternatively, the cycle track could be removed and replaced with sharrow pavement markings, which will better indicate to cyclists and drivers that these modes are mixed on Hawthorne Avenue.

The cycle track is planned to be extended (further west) with the upcoming Hawthorne Avenue project. The comments above, as well as the comments provided by the Old Ottawa East Community Association, will be forwarded to the City's Project Manager for the Hawthorne Avenue Project, as well as to OC Transpo.

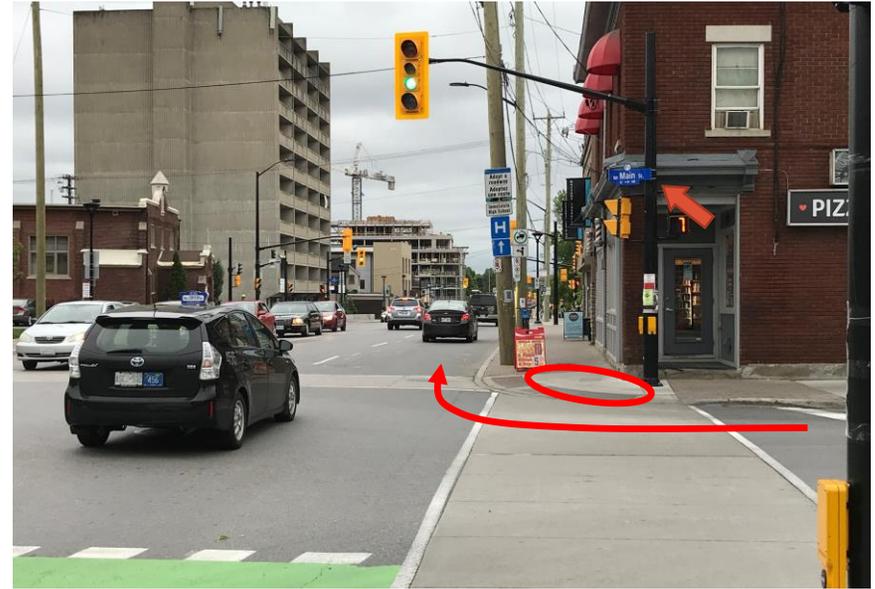
The tight turning radius for the eastbound right-turn at Hawthorne Avenue & Main Street, combined with the short building setback results in a small pedestrian refuge area. This may result in heavy vehicles mounting an occupying the small pedestrian refuge area to complete an eastbound right-turn at this location. The Main Street road sign was observed to be bent, likely as a result of a heavy vehicle encroaching the sidewalk.

Additionally, at the time of redevelopment, consider increasing building setbacks for the property located on the southwest quadrant of the Main/Hawthorne intersection.

It should be noted that the feedback received from the Old Ottawa East Community Association indicated that the community does not agree with the comment above with regard to increasing the building setbacks for 62 Hawthorne Avenue at the time of redevelopment. The community Association also does not appear to agree with the recommendation to provide a bulb-out (due to existing geometry). This section is considered a constrained area and therefore there are no countermeasures being considered. **The City will review 3-year collision history (once available) to identify if there are collision trends that could be mitigated.**

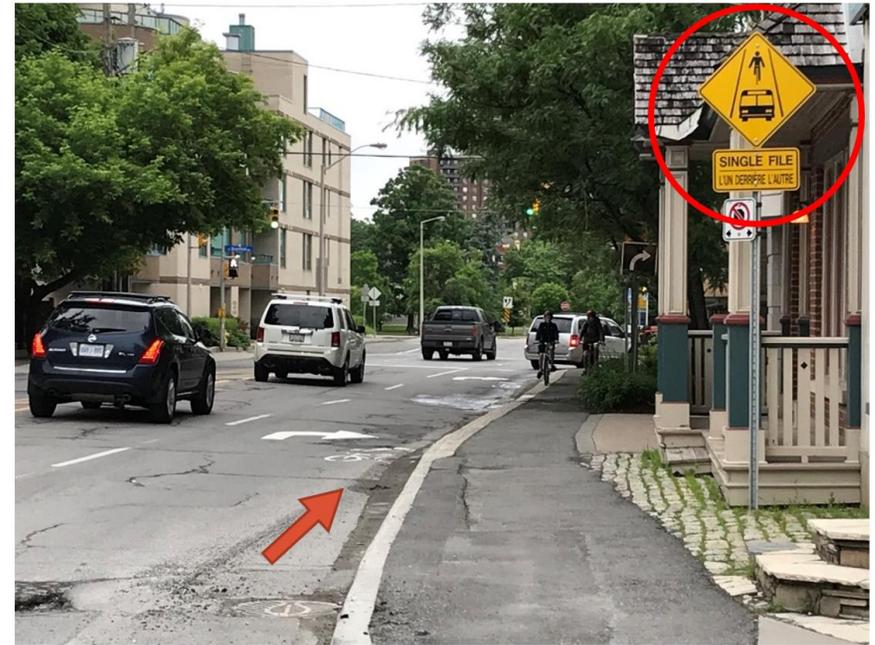
**Finding #23: Contradicting Signage, Pavement Markings and Poor Pavement Conditions – Severity Rating: Extreme**

Additionally, the pavement at this location was also noted to be in relatively poor conditions (e.g. pot holes) and given the sidewalk surface treatment is asphalt, cyclists were typically found riding on the sidewalk (i.e. because the sidewalk is not concrete, it looks like a cycle track).

Relocate sharrows to the centre of the lane. It should be noted that this lane is approximately 3.2 metres wide, which makes it a narrow lane according to Ontario Traffic Manual. In these cases, sharrows should be painted at the centre of the travel lane. The “sharrows” should also be carefully positioned in order to not interfere with the existing right-turn arrow pavement markings.

Repair damaged asphalt to create a smooth surface for cyclists and consider upgrading the sidewalk surface treatment to concrete.

Note that asphalt condition and cycling facilities will be addressed during the Greenfield reconstruction project. **In the interim, the City may repaint the sharrows centered in lane (depending on timelines).**

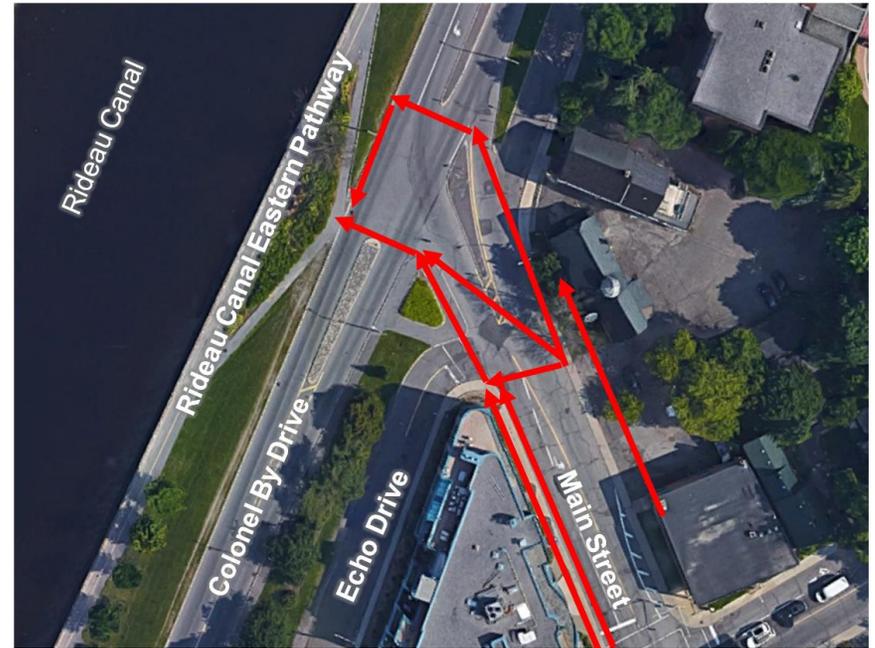
The Rideau Canal Eastern Pathway is located across from Colonel By Drive, and is expected to be used by cyclists. However, there is no guidance or crossing facilities to indicate where cyclists should cross. As a result, several cyclists were observed riding on the sidewalks on Main Street, including in the opposite direction of traffic (e.g. riding northbound on the west sidewalk or on the roadway). The figure illustrates observed northbound routes that cyclists used to cross Colonel By Drive, some of which exposed them to motor vehicle traffic.

A possible solution is to provide separate north and south cross-ride crossings that provide direction connections to/from the Rideau Canal Eastern Pathway, as opposed to a single access/egress point. However, given the substantial complexity of this intersection, a more detailed study is recommended to determine the most adequate solution. This may include reviewing operational impacts of potential modifications.

Access to the Rideau Canal Eastern Pathway will be considered during the Greenfield reconstruction project, depending on funding and NCC approval.
