# Main Street Renewal

Construction Newsletter No. 33

October 28, 2016

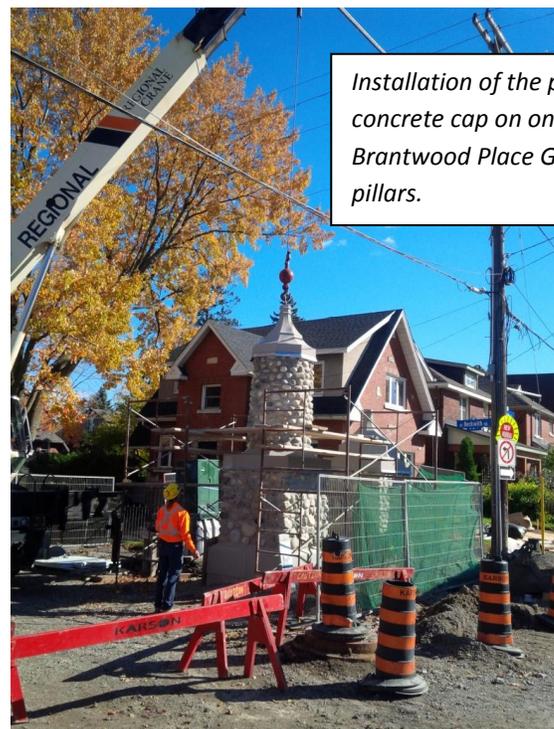
*Installation of the precast concrete cap on one of the Brantwood Place Gates pillars.*

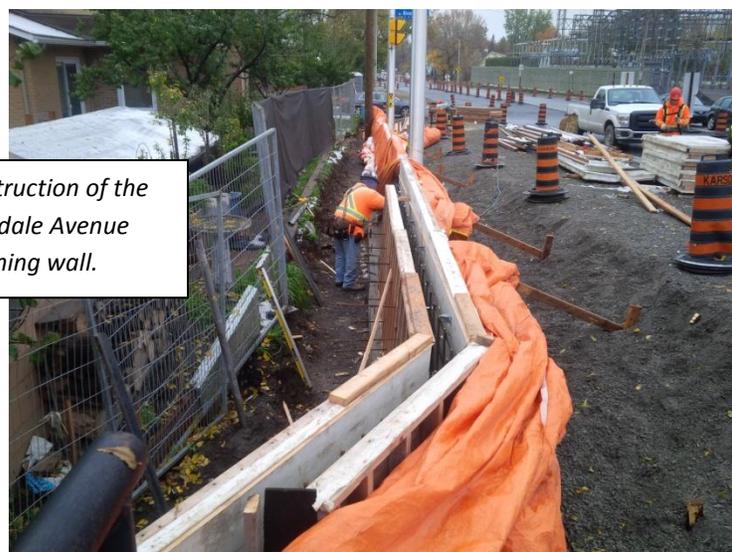
*Construction of the Riverdale Avenue retaining wall.*

- **Clegg Street to the McIlraith Bridge:** Construction of concrete sidewalks, placement of the concrete curbs, electrical work, construction of the Riverdale Avenue retaining wall, road work, paving and landscaping.

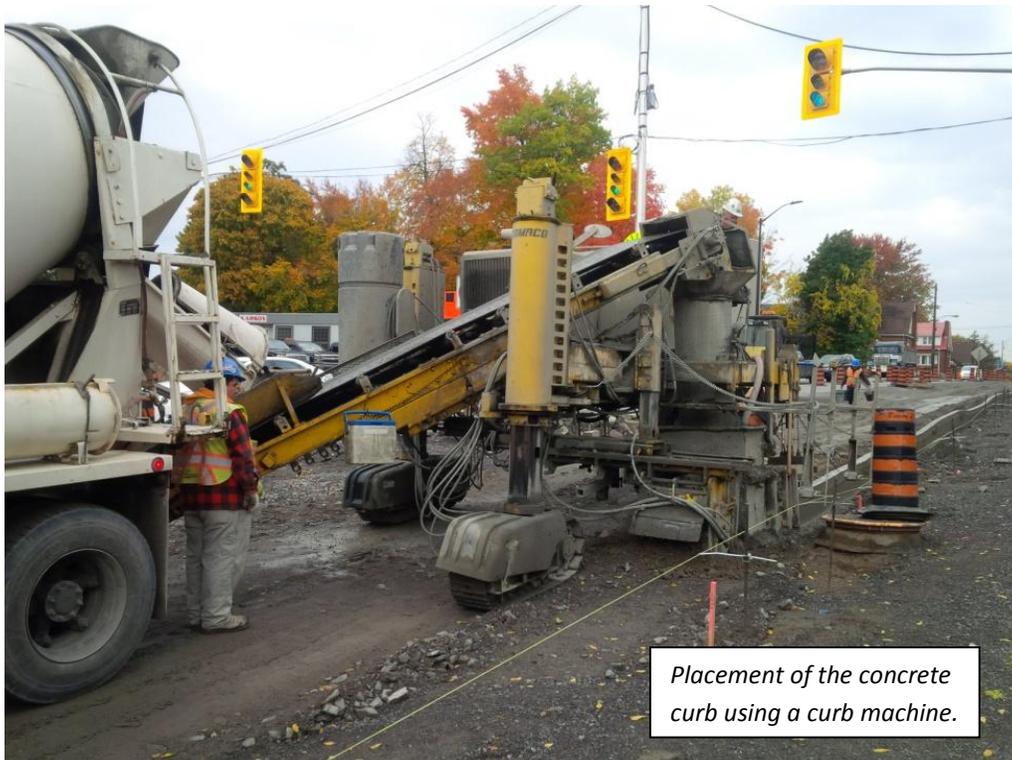
*Placement of the concrete curb using a curb machine.*

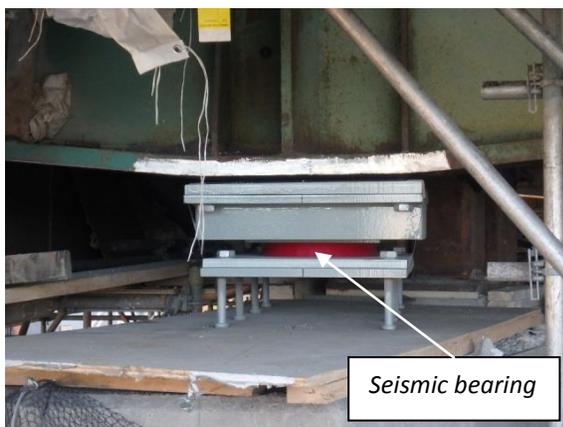
*Seismic bearing*

The most challenging portion of the work was the seismic retrofitting. Seismic retrofitting is the modification of an existing structure to make it more resistant to seismic activity. To do this, 21 seismic bearings have been installed (between the piers and the deck) and the Gerber joint of the bridge is presently being replaced by a link slab. The seismic bearings and the link slab will improve the bridge response to seismic loading. To date, half of the link slab has been installed. The traffic will be moved to the other side of the bridge next week to install the other half of the link slab.

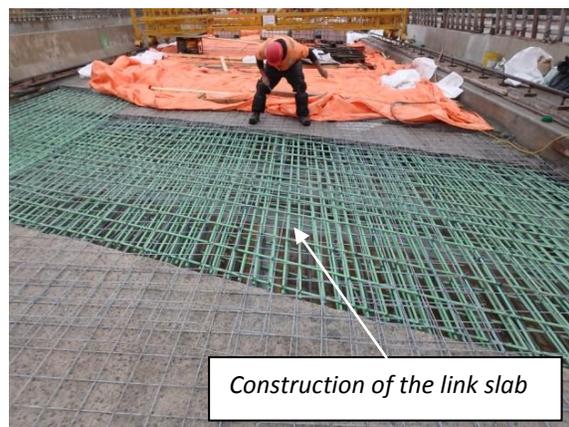
*Construction of the link slab*
