# City of Ottawa

## Main Street Road Safety Audit

FINAL REPORT

CIMA+ File Number: B000957

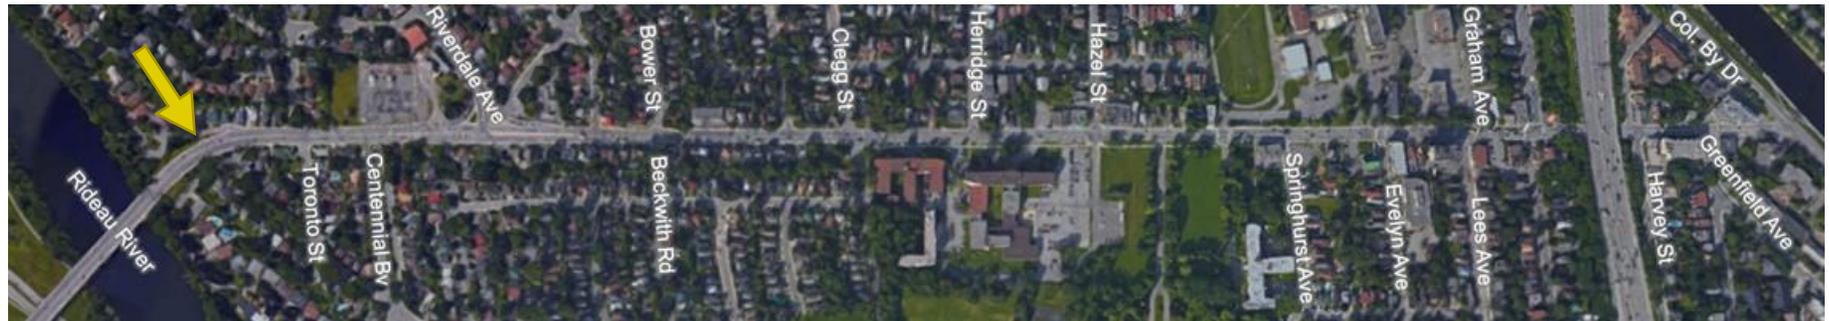
#### Location

Trucks were observed encroaching the northbound bicycle lane on the curve located north of the Rideau River bridge. The width of the bicycle lane at this point is 1.80 metres, which is the desirable width according to Ontario Traffic Manual. The width of the general purpose lane is 3.50 metres. Although these lanes are within the range recommended by Transportation Association of Canada for urban roads, similar to Main Street, large vehicles appear to have difficulty remaining within their lane along this curve (potentially due to their speed).

With enforcement and/or traffic calming treatments, the occurrence of trucks encroaching the bicycle lane can be reduced. It should be noted that since our field investigation, the City has installed vertical flex-stakes between the dedicate bike and general purpose lanes, as a measure to better delineate the two separate facilities. As such, the City should monitor truck behaviours to verify if this modification was effective.

Flexible delineators (“flex stakes”) are installed annually at this location (removed during the winter months due to road maintenance requirements). The flex stakes are expected to keep vehicles (including trucks) from encroaching in the cycling lane. **The City will review operations during the winter months when the flex stakes are not in place.**

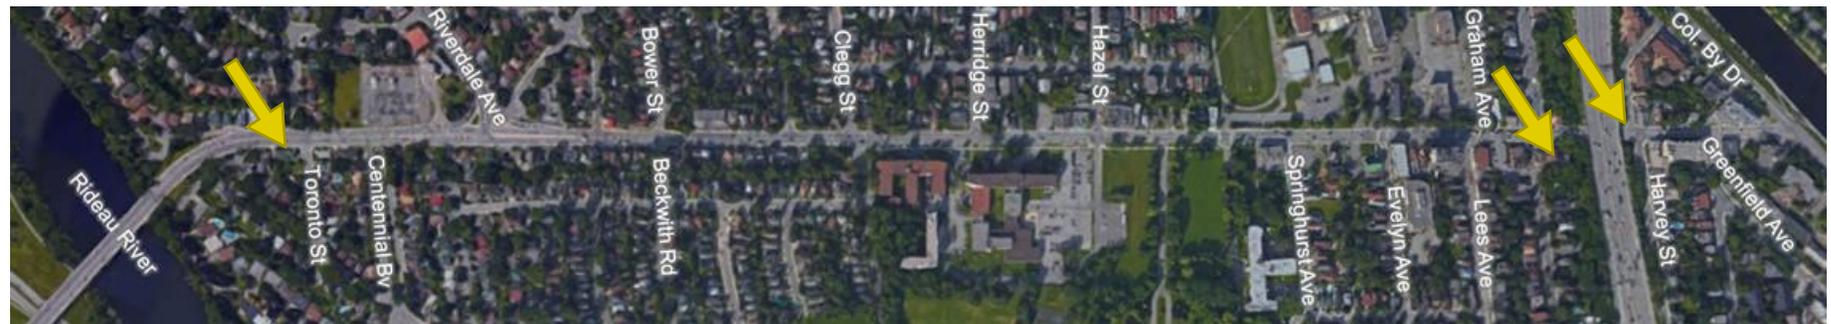
**Location**

At some locations, the ground mounted Reserved Bicycle Lane signs are installed adjacent to the sidewalk. This makes the diagonal arrow on the sign point at the sidewalk, as opposed to the cycle track. This was observed at three locations along Main Street: northbound near Toronto Street and near Hawthorne Avenue, and southbound near Harvey Street.

Where this condition occurs, the Reserved Bicycle Lane signs should be mounted to the left of the cycle track, such that the diagonal arrow points at the cycle track. Although this may not be a typical standard, it provides a more clear indication of where cyclists should ride.

Moving the signs to the left of the cycle track would increase the driver workload, particularly in locations where there are already other signs posted nearby (such as in the photo above). Additionally, primary signs are typically placed on the right side of a facility, making this sign placement consistent with what cyclists may expect. No changes are planned since it is not expected that the sign placement would be the cause of conflicts or collisions.

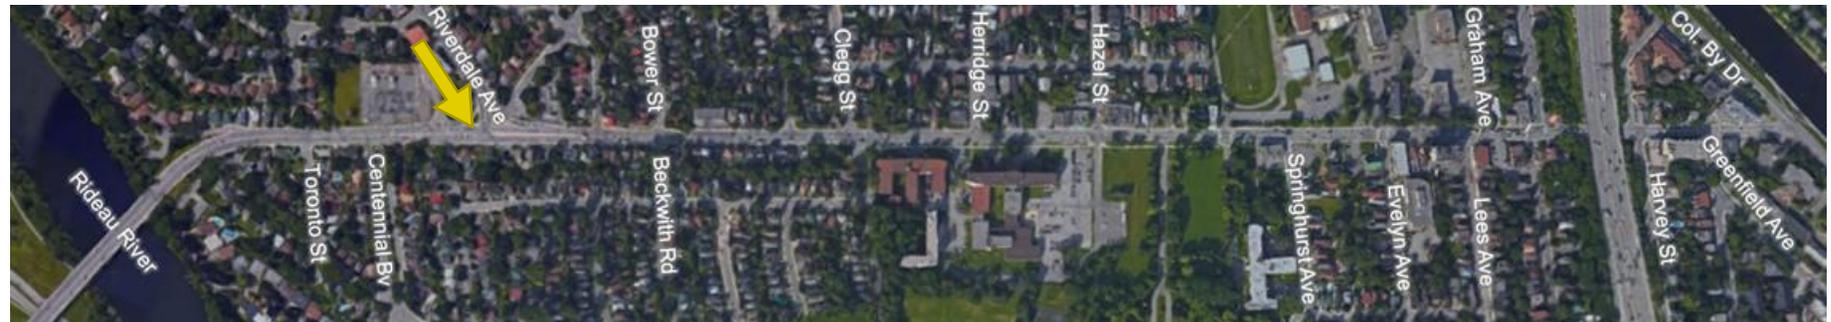
**Location**

It should also be noted that due to the downslope of Main Street at this location, in the southbound direction, cyclists gain speed and will have difficulty completing an emergency stop, if needed.

See response to Finding # 4 above. At this time, an additional sign facing northbound traffic is not recommended since the sign would add to driver workload and may or may not actually provide a benefit.

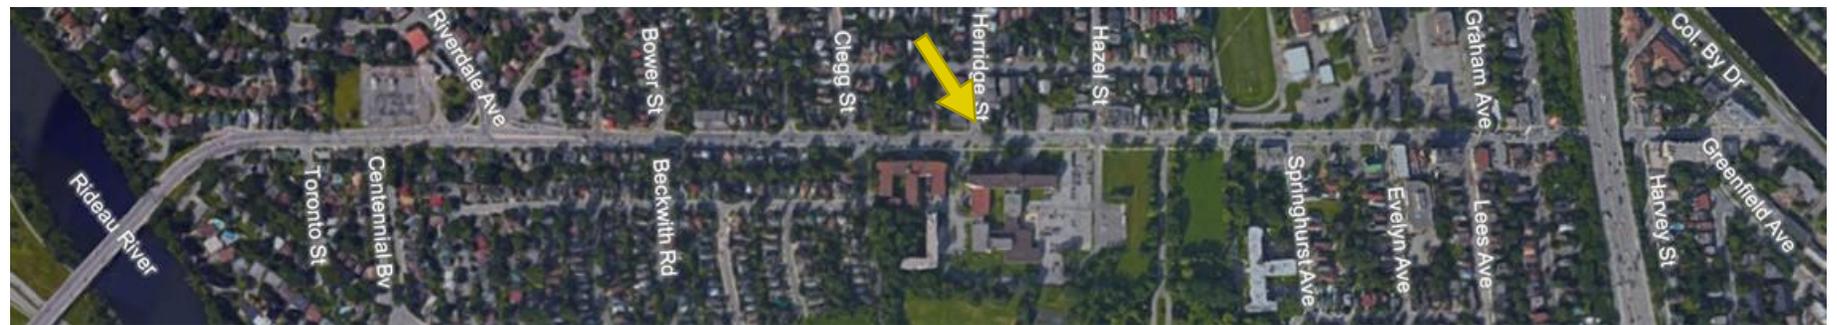
**Location**

A bike box is provided at Herridge Street & Main Street. During the field investigation, vehicles were observed encroaching the bike box while advancing to clear sight lines (i.e. pulling up to look for oncoming traffic).

Based on feedback received, it appears as though the purpose of this bike box is not well understood. During a public meeting with the Old Ottawa East Community Association, there was quite a bit of discussion regarding the intent of the bike box. Additionally, the written feedback received from the Community Association also indicates that cyclists could cross Main Street at Hazel or Clegg (both of which are signalized), rather than crossing at Herridge. Whereas this is true, these routes would lead cyclists to either go out of their way in order to reach their destination, or to cycle the wrong direction on the east side of Main Street.

Given that it is not expected that the bike box is likely to cause any collisions or near misses, the bike box will remain. If, however, the City observes concerns regarding cyclist safety at this crossing (ie: complaints regarding near misses, or collision data), the City will consider removing the depressed curb on the east side of Main Street (across from Herridge) and the bike box on Herridge. **The City will review 3-year collision data once available.**

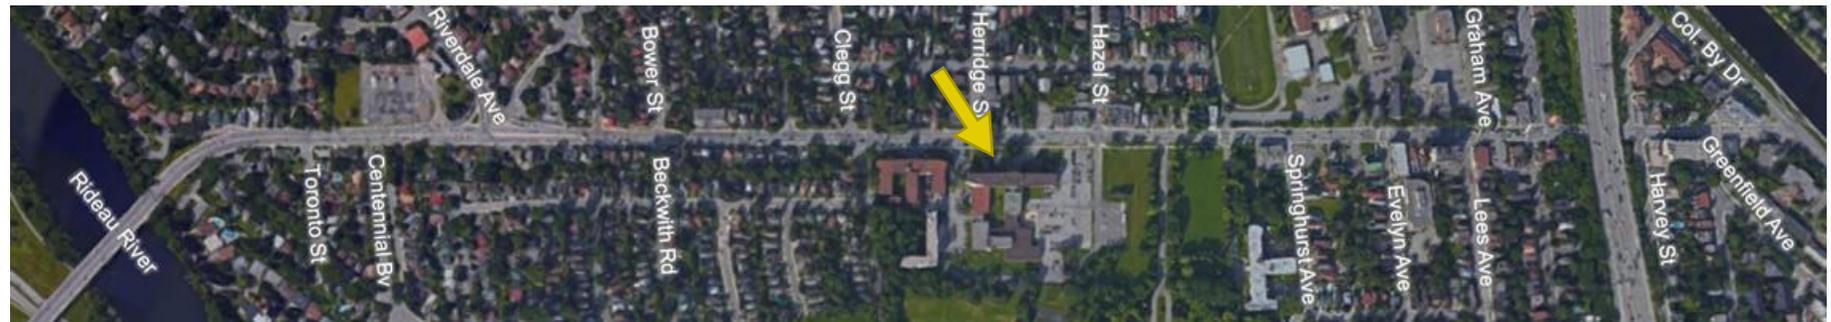
**Location**

A Stop sign and waiting area is provided opposite to Herridge Street (i.e. east side of Main Street) to indicate to cyclists where to cross Main Street. A similar treatment is not provided on the west side of Main Street. This location is in front of Saint Paul University, which is a major pedestrian and cyclist generator within the study area. During field investigations, several cyclists were observed arriving at the University from the north, riding on the sidewalk on the east side of Main Street (i.e. riding the wrong way on the cycle track or sidewalk). This could be due to the lack of an indication for where to cross Main Street from the west to the east side.

See client response for Finding #9. The bike box is intended to facilitate the eastbound crossing.

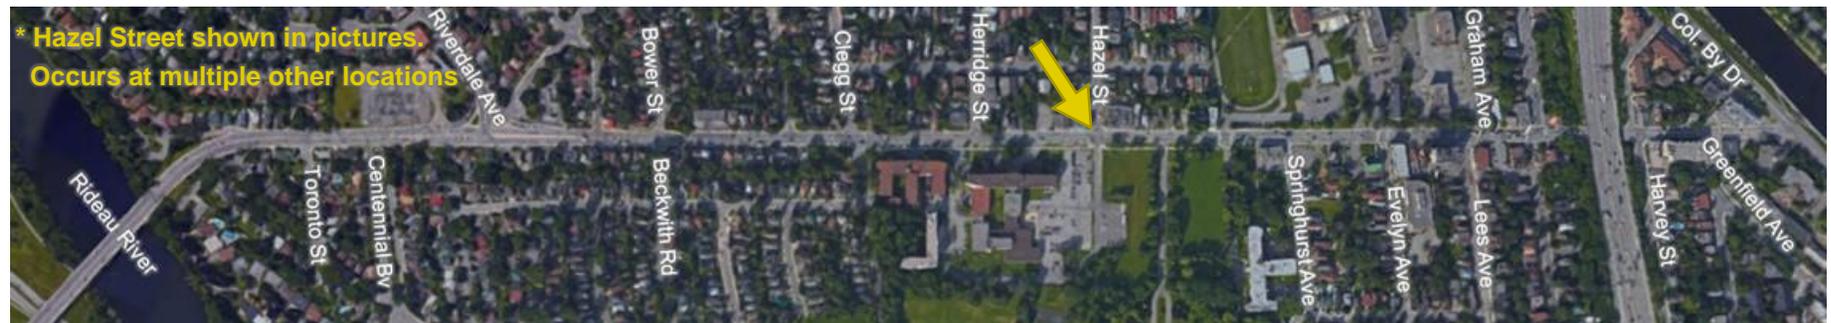
**Location**

At several locations, bicycle signal heads were found to be obstructed by signage as cyclists approach intersections. This may not provide cyclists sufficient distance/time to observe red light indications. This was observed at several intersections within the study area, particularly where the cycle track shifts laterally on the approach to an intersection.

The City will review signage along the corridor and will determine if any changes should be made to improve visibility of signal heads.

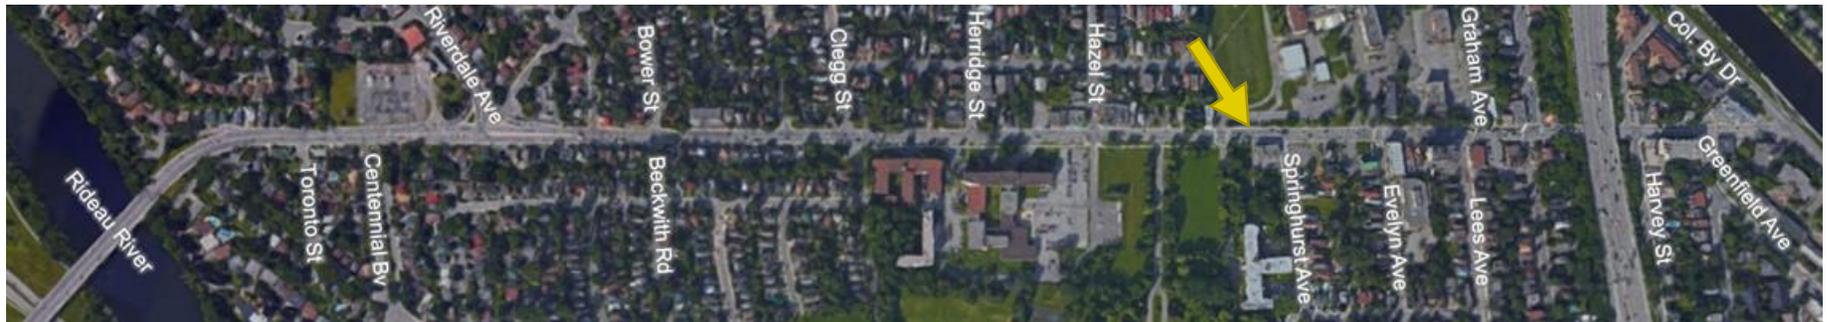
#### Location

The picture and location figure shows a bus stop near Main Street & Oblate Avenue; however, this finding was observed at multiple locations within the study area.

The City will review signage along the corridor to identify if there is any signage that should be changed due to sign clutter and driver workload. It should be noted however that in situations such as the one shown above, it is generally accepted that the signs can be located in near proximity to each other if required and/or if the general message of the signs are compatible.

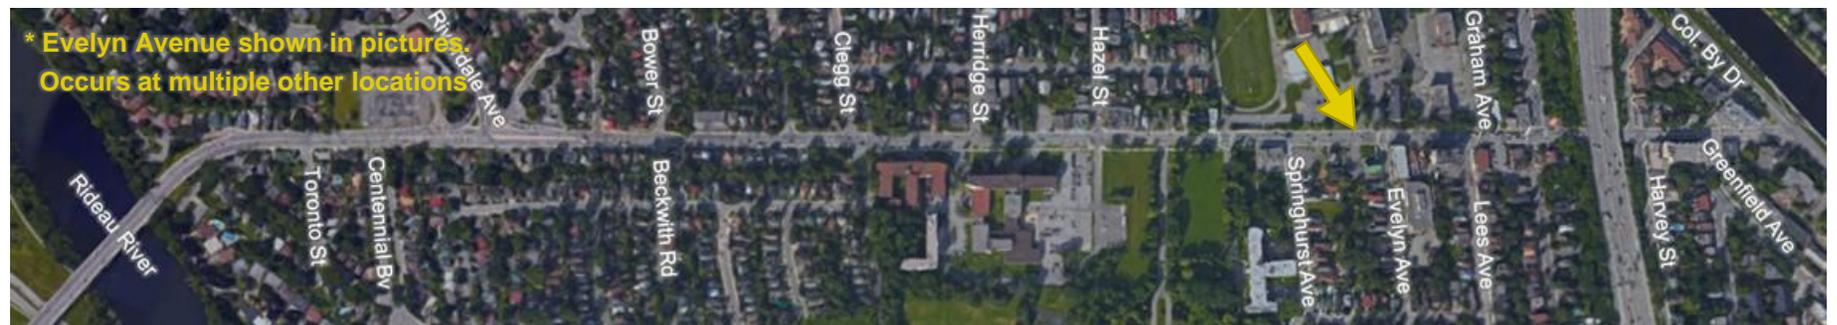
**Location**

Additionally, one bus was observed offloading passengers outside the areas designated bus stops (i.e. areas with zigzag patterns). This was observed during the PM peak hour, when congestion created long queues. A passenger was seen getting off the bus and across the cycle track without looking for approaching cyclists.

The signs and markings implemented at this location are based on the design that the City of Ottawa was using while the Main Street facilities were being designed. Since this time, there have been changes made to the standard design that the City uses. OC Transpo is currently finalizing the recommended standard design. The input received at this location will be provided to OC Transpo for their information in creating the new design standard.

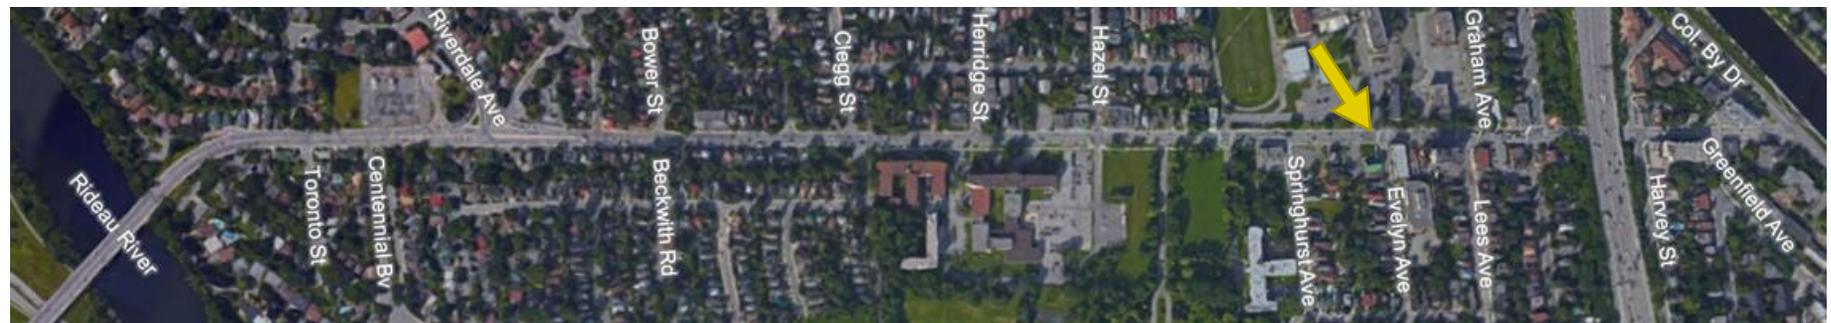
#### Location

Several cyclists were observed riding on the sidewalk and travelling the wrong way on the provided cycle tracks, as well as crossing Main Street using crosswalks without dismounting. One cyclist was asked if there was a specific reason why they preferred using the sidewalk in the opposite direction of the cycle track, and she indicated that it felt safer than riding under the construction scaffolding on the east side of Main Street, near Oblate Avenue.

Other inappropriate cyclist behaviours included disobeying the red light at bicycle signals. This was observed at several locations within the study area, with one of the most critical locations being the southbound approach to Riverdale Avenue, where the downgrade can encourage high bicycle speeds.

Cycling behaviours were also identified as a priority item in the written feedback received from the Old Ottawa East Community Association, as were pedestrian behaviours and motorist behaviours. **The City will employ ambassadors in Spring/Summer 2019 (near the start of the next cycling season) in order to help emphasize the purpose of various cycling facilities.** If required, enforcement may be requested in the future.

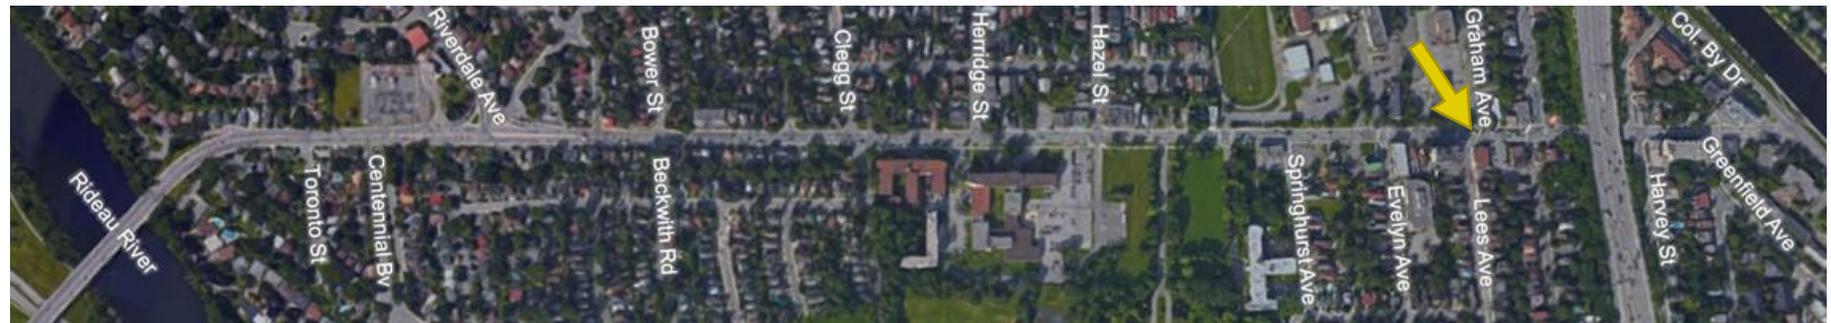
**Location**

The southbound Main Street cycle track begins at Graham Avenue. The design drawings indicate green coloured pavement at the southwest corner to show where cyclist should enter the cycle track. However, the actual field condition does not include the coloured pavement. The start of the cycle track appears to be a regular sidewalk. During the site visit, cyclists were observed riding on the crosswalk and part of the sidewalk before getting to the cycle track.

Based on our current design practices, this section of cycle track would typically be asphalt rather than concrete. Given that it is not cost effective to remove the concrete and replace it with asphalt, **the City will add green thermoplastic paint to this location to help delineate the cycling facility.**

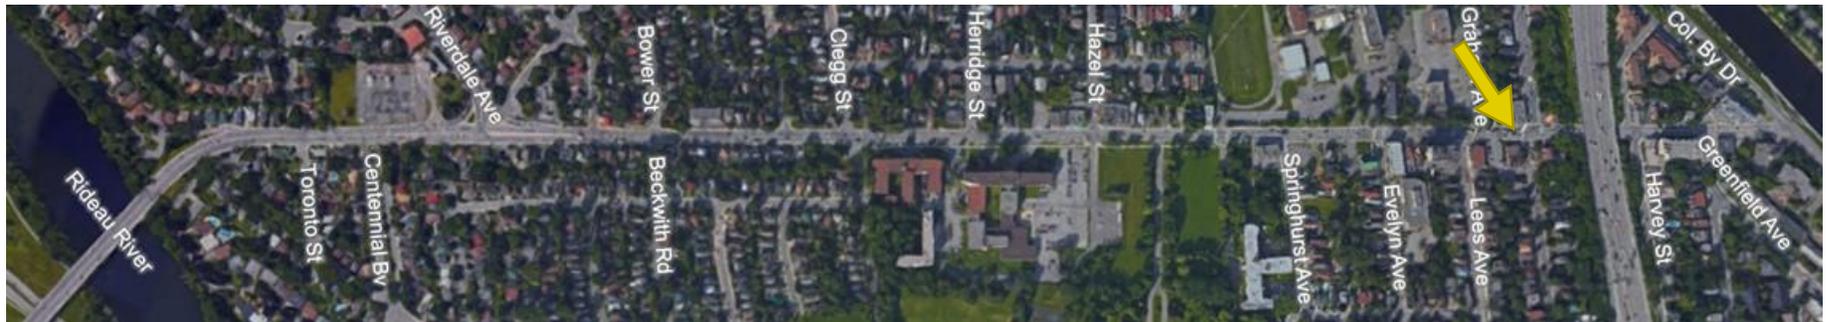
**Location**

At the northernmost section of the study area, cyclists share the road with motor vehicles. “Sharrow” pavement markings are provided to indicate the shared condition; however, several of these markings are significantly faded.

Ensure pavement markings are maintained throughout the year to indicate to drivers and cyclists the shared condition of the roadway.

These markings are already be included in the City’s annual pavement marking maintenance schedule.

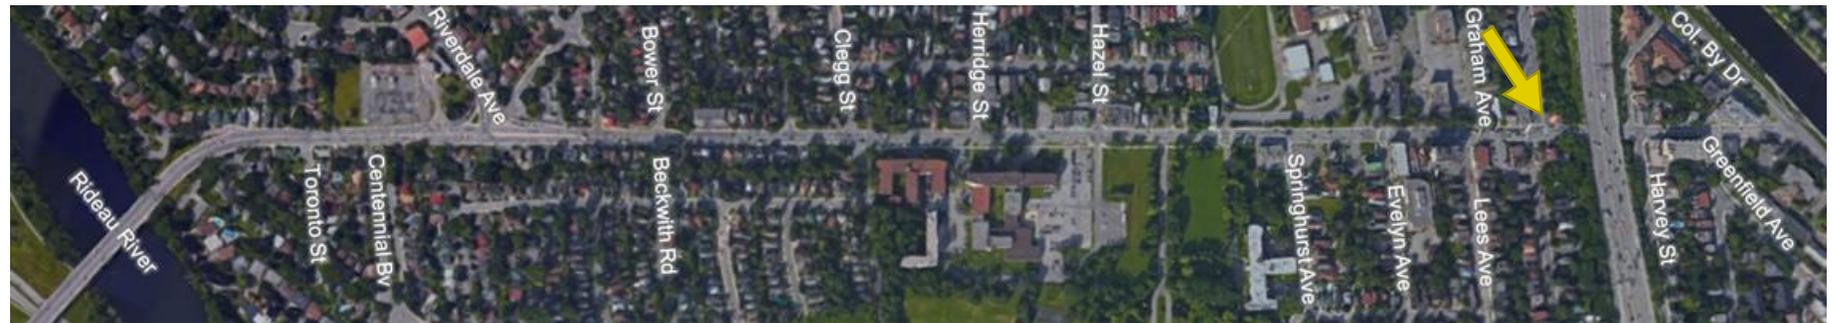
**Location**

A very short section of cycle track (approximately 10 metres) is provided on the north side of Hawthorne Avenue, immediately west of Main Street. A bus stop is located west of the termination of this cycle track section. Buses were observed encroaching this cycle track with the front overhang when completing a northbound left-turn from Main Street.

Additionally, multiple cyclists were observed not using this cycle track (either riding on the sidewalk or on the roadway). Potential reasons for this are; there is no cycle track on Main Street southbound, and using the cycle track may be uncomfortable for cyclists, as the cycle track is raised and depressed over a short distance.

Consider extending this section of cycle track. However, this would require moving the existing bus stop further away from the intersection. Alternatively, the cycle track could be removed and replaced with sharrow pavement markings, which will better indicate to cyclists and drivers that these modes are mixed on Hawthorne Avenue.

The cycle track is planned to be extended (further west) with the upcoming Hawthorne Avenue project. The comments above, as well as the comments provided by the Old Ottawa East Community Association, will be forwarded to the City's Project Manager for the Hawthorne Avenue Project, as well as to OC Transpo.

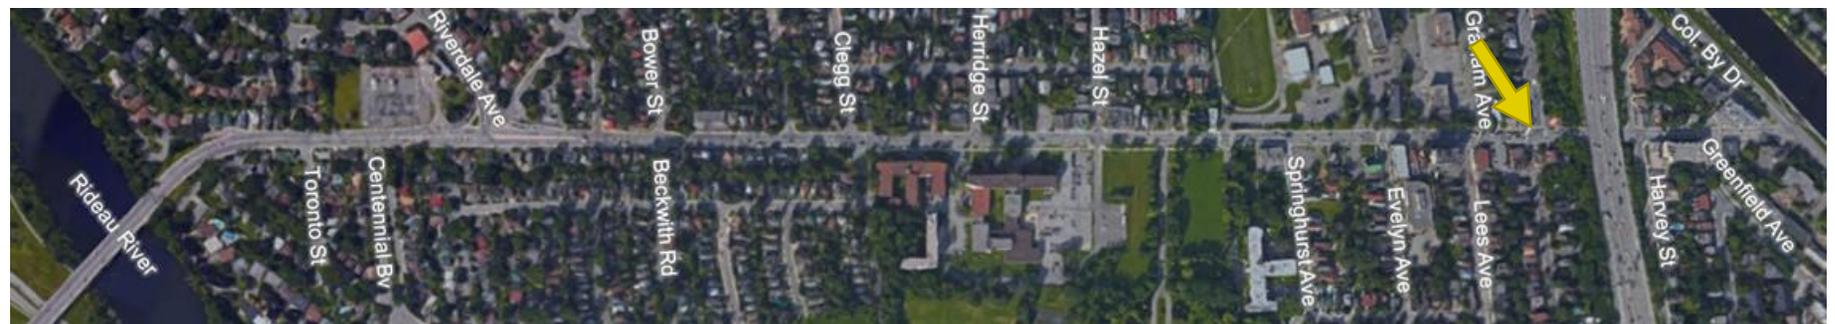
**Location**

The tight turning radius for the eastbound right-turn at Hawthorne Avenue & Main Street, combined with the short building setback results in a small pedestrian refuge area. This may result in heavy vehicles mounting an occupying the small pedestrian refuge area to complete an eastbound right-turn at this location. The Main Street road sign was observed to be bent, likely as a result of a heavy vehicle encroaching the sidewalk.

It should be noted that the feedback received from the Old Ottawa East Community Association indicated that the community does not agree with the comment above with regard to increasing the building setbacks for 62 Hawthorne Avenue at the time of redevelopment. The community Association also does not appear to agree with the recommendation to provide a bulb-out (due to existing geometry). This section is considered a constrained area and therefore there are no countermeasures being considered. **The City will review 3-year collision history (once available) to identify if there are collision trends that could be mitigated.**

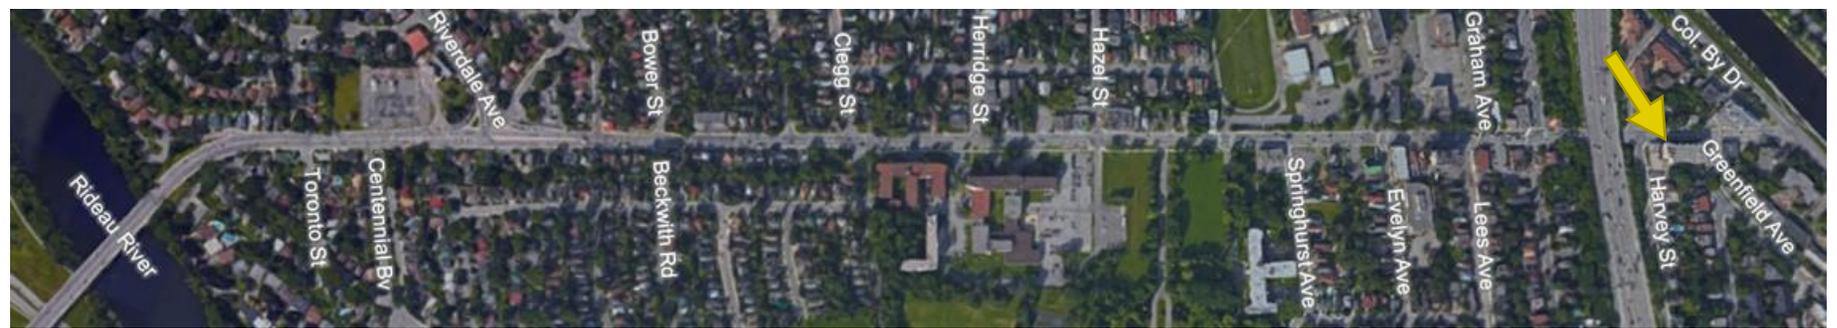
**Location**

**Finding #23: Contradicting Signage, Pavement Markings and Poor Pavement Conditions – Severity Rating: Extreme**

Note that asphalt condition and cycling facilities will be addressed during the Greenfield reconstruction project. **In the interim, the City may repaint the sharrows centered in lane (depending on timelines).**
